**ANNUAL REPORT
FOR THE
ROCKY FLATS ENVIRONMENTAL TECHNOLOGY SITE
GROUNDWATER PLUME TREATMENT SYSTEMS
January 2003 through December 2004**

August 1, 2005

SW-A-005120

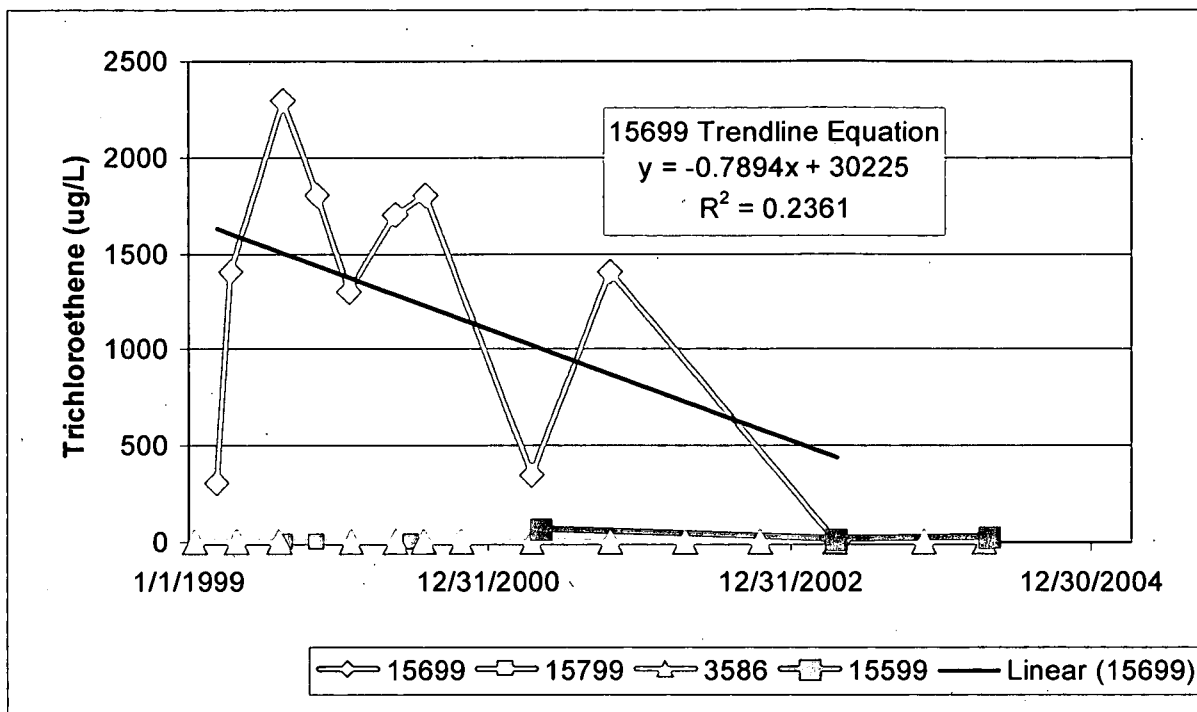
Figure 3. Mound Site Plume Downgradient TCE Concentrations

Concentrations in the downgradient wells indicate that the residual contamination levels appear to be declining and that the collection system tends to mitigate downgradient plume concentrations. For example, concentrations at Well 15599, frequently dry in the past, have decreased since the previous sample collected in 2001. Although there is variability in the concentrations, a decrease in TCE concentrations was noted in Well 15699. PCE concentrations are more variable, and the downward trend is not as evident. This well is located within the preferential flow path for the Mound Site Plume and along the trend of the highest plume concentrations defined in the pre-remedial investigation (DOE 1997a).

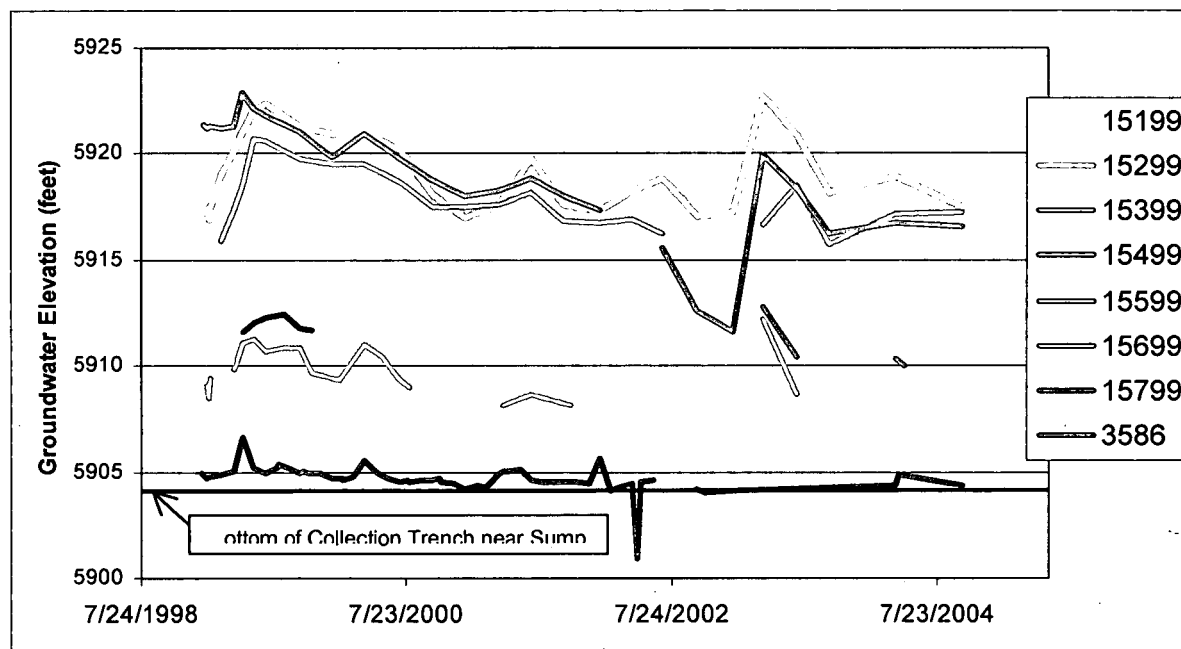
Figure 5. Mound Site Plume Water Elevations in Wells vs. Time

The groundwater elevations in wells downgradient of the trench recovered a little from the drought in Spring 2003; however, by Fall 2003, all three wells were dry again and remained relative low or dry throughout 2004. Seasonal water level fluctuations are approximately two to seven feet in upgradient and downgradient wells. Seasonal fluctuations were higher in 2003 because drought conditions in the beginning of the year, followed by a heavy snowstorm in March 2003. Groundwater elevations in Well 3586, near South Walnut Creek, remained within a few feet of the normal creek elevation of 5,903 feet in this area.

In January 2003, drought conditions greatly reduced the groundwater flow. As a result, the two outside downgradient wells, 15599 and 15799, were dry and the water level at 15699 was greatly reduced.

After the March 2003 precipitation event, a measurable water level was re-established at Well 15599 on the western side of the Mound Site Plume, but not at 15799. The increase in water levels was likely a result of the heavy snow pack melting and percolating downwards into the groundwater. The slope on the eastern side of the collection trench is flatter and may have allowed for more percolation into the soil. On the steeper sloped, western side of the collection trench, snowmelt is more likely to become run-off. By July, the downgradient groundwater profile returned to normal conditions illustrated on Figure 6. This is consistent with the intended design and indicates that the collection system is working effectively.

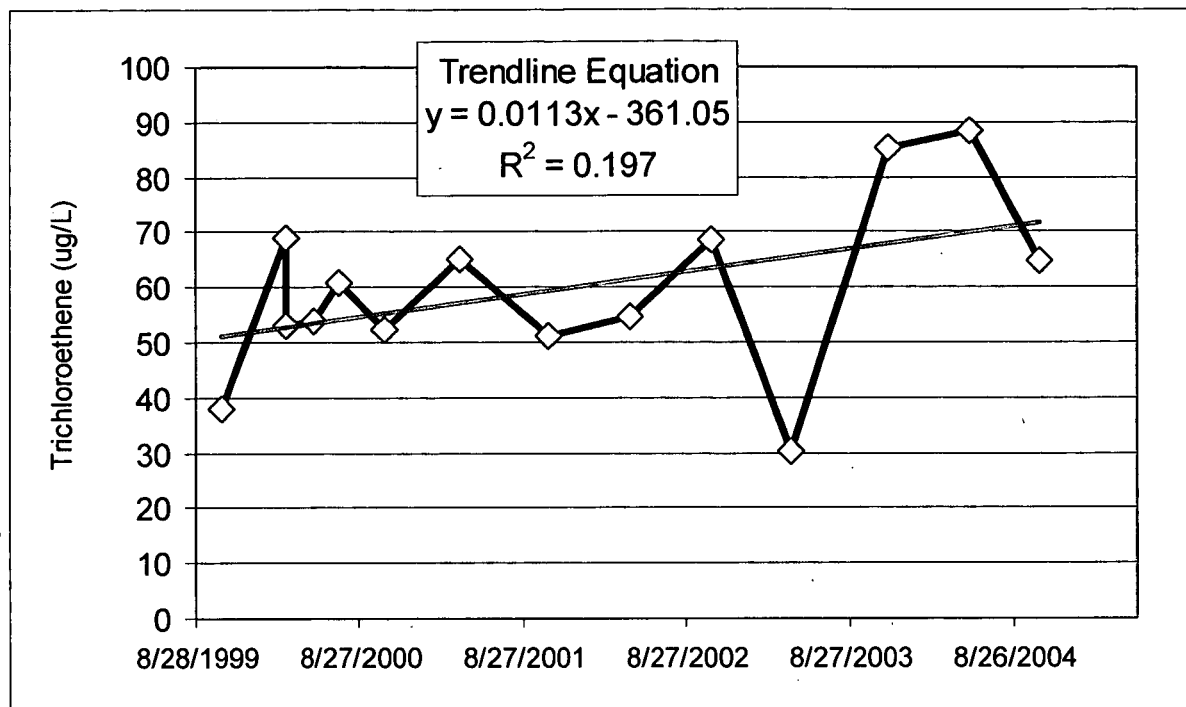
Figure 8. TCE Concentration in Well 95199

Grab samples collected in March 2003 from Pond B-2 show significantly higher VOC concentrations than other sampling events. These samples were collected in the winter and ice on the pond probably reduced volatilization. These results are also much higher than what has been previously observed in adjacent groundwater Well 95199.

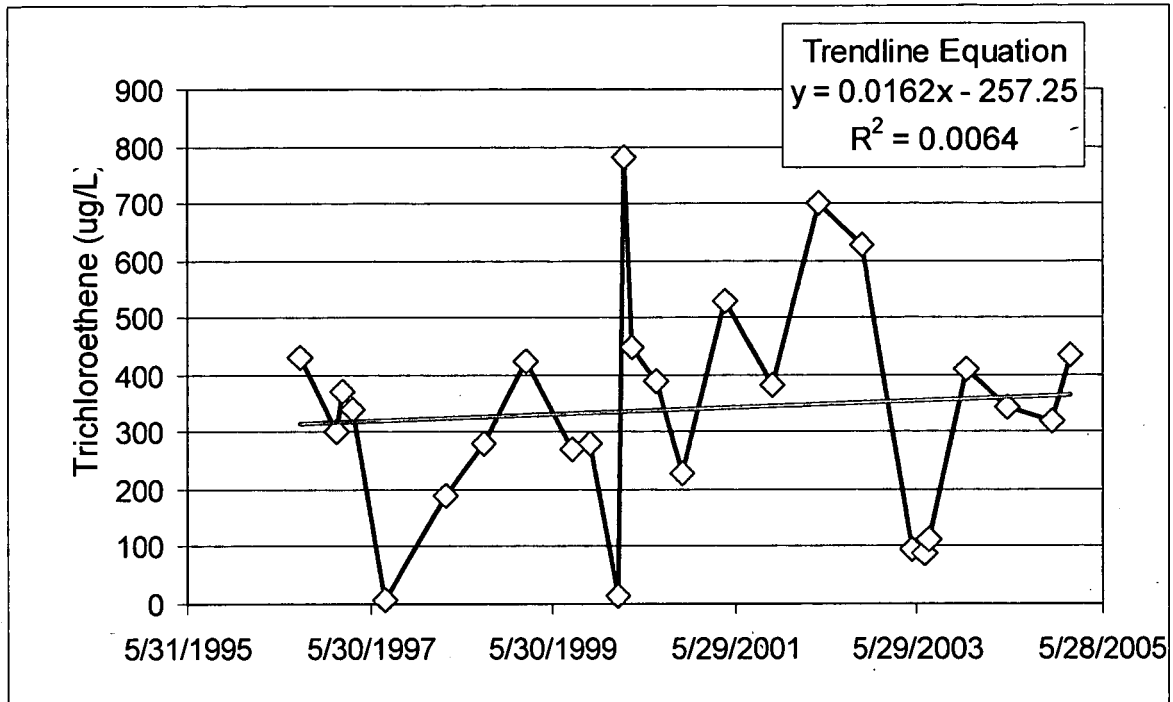
Figure 9. Historical TCE Trend in Well 23296

Groundwater TCE concentrations at Well 23296 vary significantly (Figure 9). Figure 10 shows the sample results after the treatment system was installed. Contaminant concentrations in 2003 are lower than in the past; however, 2004 concentrations were similar to previous concentrations. While there appears to be a slight downward trend, the data variation does not support a definite conclusion. Figures 11 and 12 show similar trends in PCE concentrations. IMP monitoring is expected to continue at this location to determine if there is a downward trend in concentrations. Additional statistical analysis of groundwater trends using Seasonal Kendall trend testing is presented in Appendix D of the Annual RFCA Groundwater Monitoring Report (K-H 2004a).

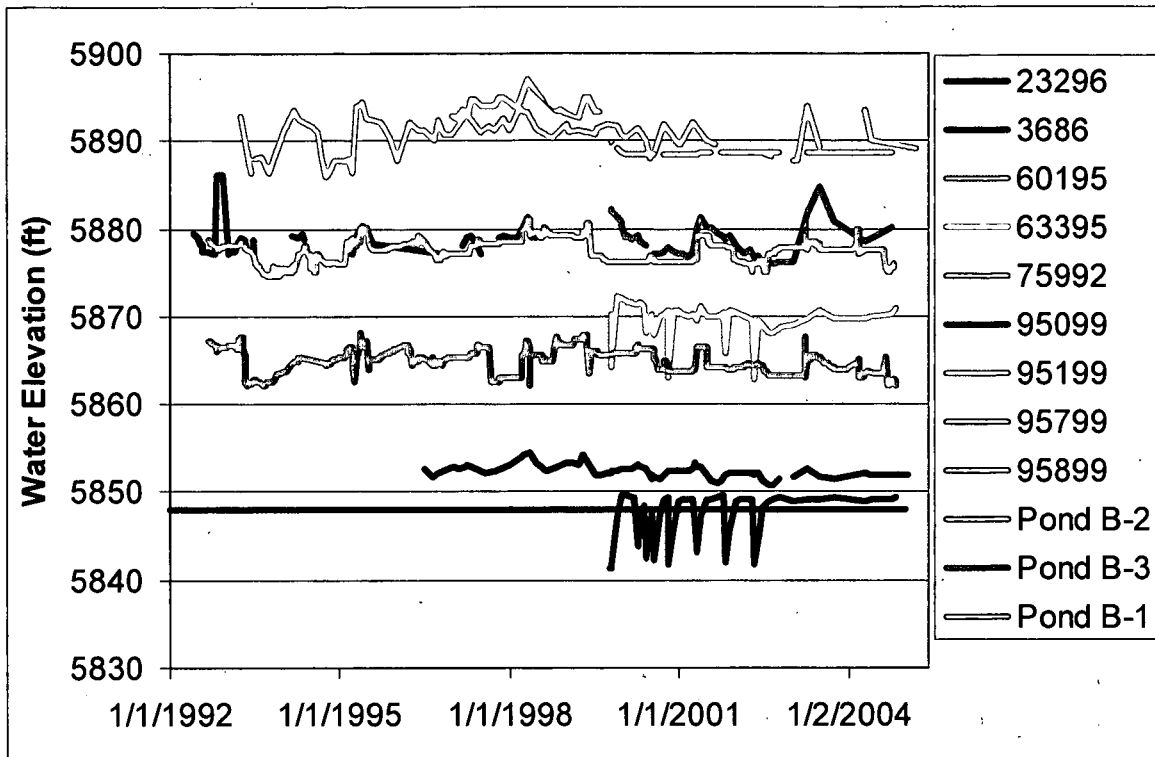
Figure 13. East Trenches Plume System Water Elevations

Three wells are immediately downgradient of the collection trench and one well is located east and downgradient of the collection trench (Figure 7). These wells continue to demonstrate there is a strong gradient downward to the northeast. Well 95299 is always dry, providing evidence that there is no groundwater flow from the ponds or from groundwater bypassing the trench in this area.

Well 23296 is adjacent to Pond B-3 and shows less water level fluctuation probably because its water level is dominated by the water levels in Pond B-3. Pond B-3 pond water is held at a near constant elevation by its discharge pipe.

At Well 95199, located downgradient of the middle of the collection trench, groundwater elevations appear to be influenced by Ponds B-1, B-2, and South Walnut Creek. These ponds are isolated from the main drainage system and only collect local area drainage. Pond water is usually not discharged, but is allowed to evaporate or infiltrate into the ground. Therefore, water levels rise in these ponds because of precipitation events. The fluctuations seen in the groundwater elevations for Well 95199 also appear to be the result of precipitation events and reflect the influence of Pond B-2 on this area. The higher water levels in this well indicate that there may be some groundwater flow towards the collection trench from the north. As shown on Figure 13, the gradient appears to change direction over time, sometimes flowing from Pond B-2 to the well and towards the collection trench.

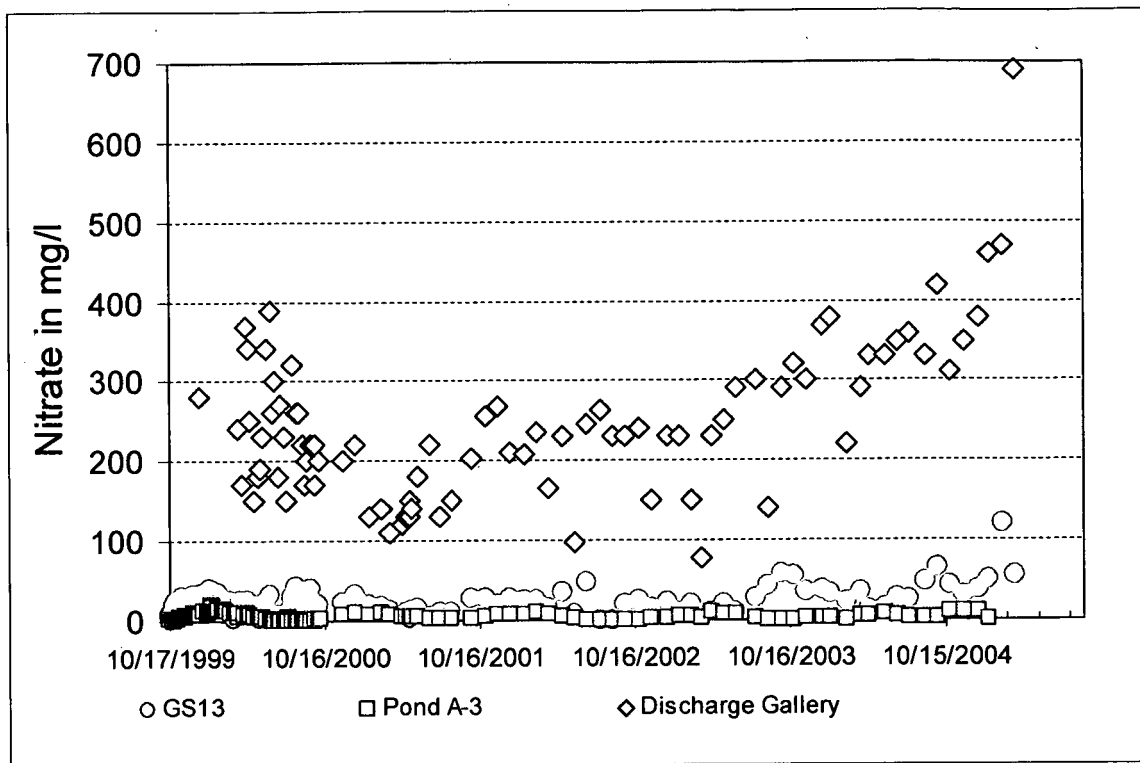
Figure 17. Nitrate Concentrations in Solar Ponds Surface Water Locations

GS13 nitrate concentrations are significantly lower than the discharge gallery indicating that phytoremediation is occurring in this area from the established plants at the discharge gallery, and that the higher flow volume in the stream dilutes the discharge gallery effluent.

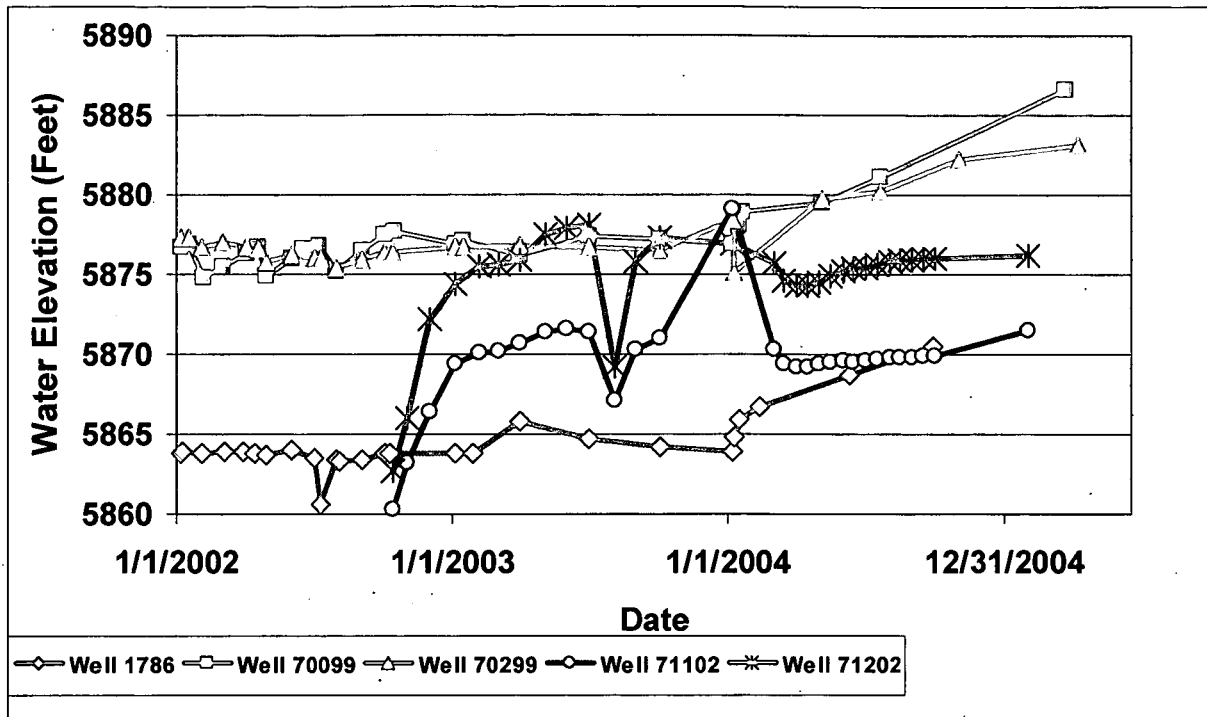
Figure 19. SPP System Downgradient Well Water Elevations

Water levels in the downgradient wells of the system were monitored monthly. These data are provided in Table 24, Table 25, and on Figure 19. The groundwater elevations in the downgradient wells were relatively stable during 2003. In 2004, the water elevations rose at all locations except 71202. Some surface features including a parking lot and roads were removed in this period, which could have increased infiltration. Other changes at the site, in addition to climatic changes, could have also increased infiltration. Groundwater elevations in the two newest piezometers (71102 and 71202) increased 15 to 18 feet since installation. This rise might be a result of the water levels equilibrating in the tight formations after well installation, or to a leak in the collection trench panels. The pump maintains water levels below the elevation of the potential leak, so water levels should drop with time in these piezometers water level changes are associated with a leaking panel.

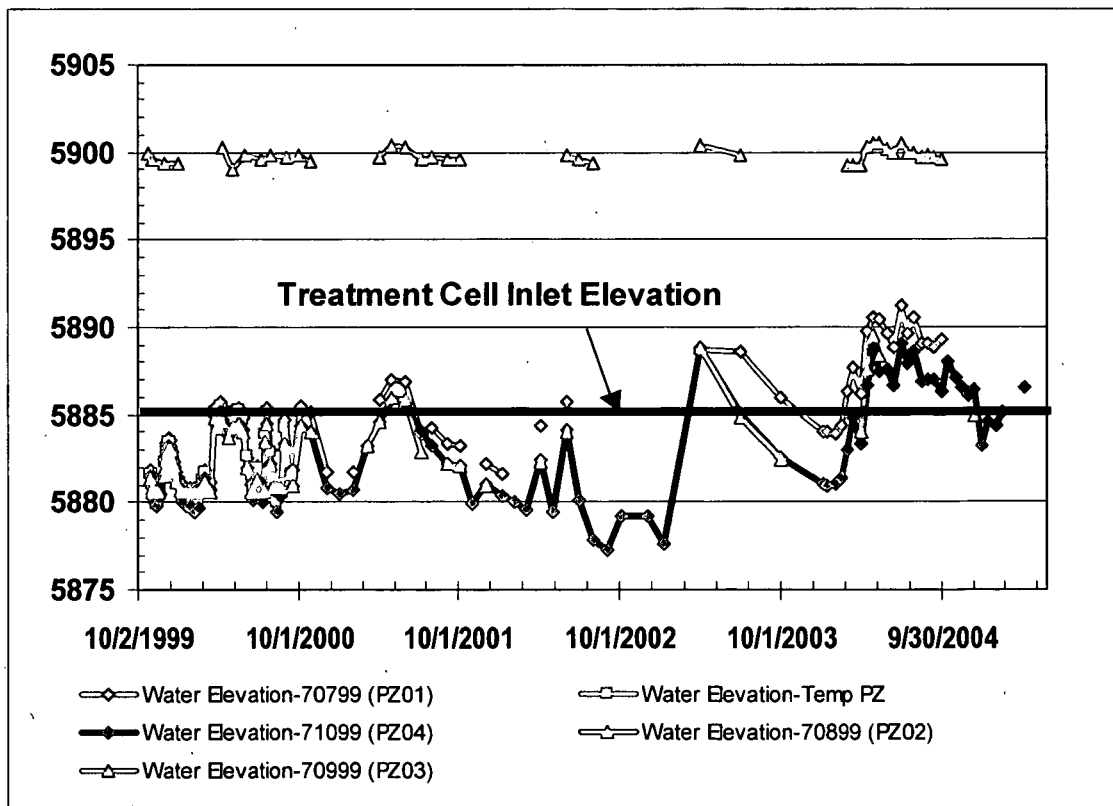
Figure 20. SPP Collection Trench Piezometer Water Levels

Water levels within the collection trench are monitored at five piezometers at 70799, 70899, 70999, 71099, and Temp PZ. The inlet to the treatment cell is 5,885 feet above msl and the bottom of the collection trench is approximately 5,875 feet above msl. As shown on Figure 20, water levels in four of the piezometers fluctuate between 5,880 and 5,891 feet above msl. The fifth piezometer (70999), located at the higher, east end of the trench, has a minimum measurable water elevation of 5,900 feet. By design, water collected in this part of the trench drains to the west. This piezometer is generally dry when the water level of the other piezometers drops to 5,880 feet; however, during the last half of 2003 it was dry even though water levels were high at other locations.

The pump installed in 2002 is set to keep water in the sump below an elevation of 5880 feet, which should result in similar water elevations in the piezometers near the sump (all but 70999). The ability to maintain this level is limited by the capacity of the pump. The pump capacity was exceeded after the heavy March snowstorm in 2003 and the water level rose in the trench. The water level continued to rise in the trench and remained elevated for some time, even with continued pump operation. Although the pump continued to operate and there was flow out of the treatment system, the elevated water levels in the trench indicated a partially plugged sump screen. The sump was redeveloped in 2004. Similar problems were observed in 2004. Some equipment and flow problems were identified and corrected in 2004 and 2005. Additional details are in Section 4.3.

There are significant differences in groundwater elevations between 70799 and the two nearby piezometers, 70899 and 71099 that were not observed in the past. One potential explanation is that the pump in the collection trench causes fluctuation of water levels within the collection trench. Depending on when the measurements are made, there can be a substantial amount of draw down when the pump is on, resulting in a lower groundwater elevation in 70799.

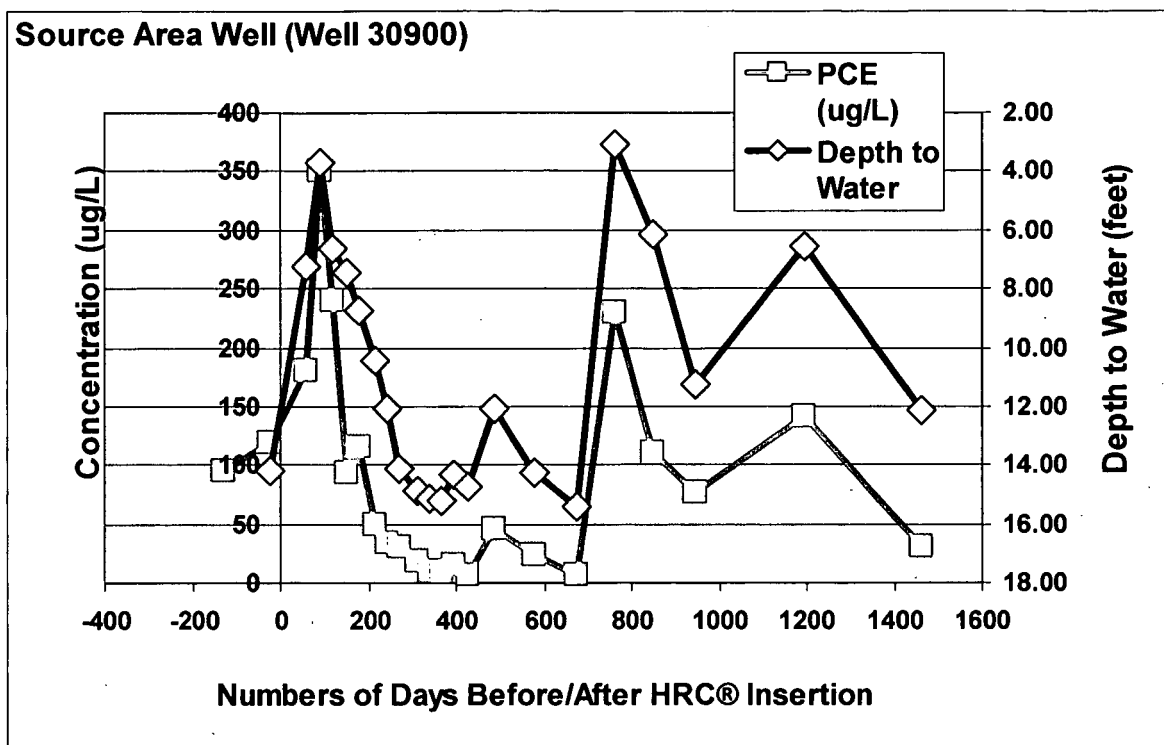
Figure 26. PCE Concentration and Depth to Water in Source Area Well 30900 versus Time

As shown on Figure 26, as the water table rises, higher contaminant concentrations are seen in the source area well (Well 30900). HRC® and other possible hydrogen donors like ketones are present in the vadose zone and as the water table rises into the vadose zone, they are released into the groundwater, inducing more biological activity. At the same time, additional contaminants are available because more contaminated soil is now below the water table and available for biological and chemical degradation. The lower concentrations of PCE are probably because less PCE is being released to the aquifer as more PCE in the soil and groundwater degrades.

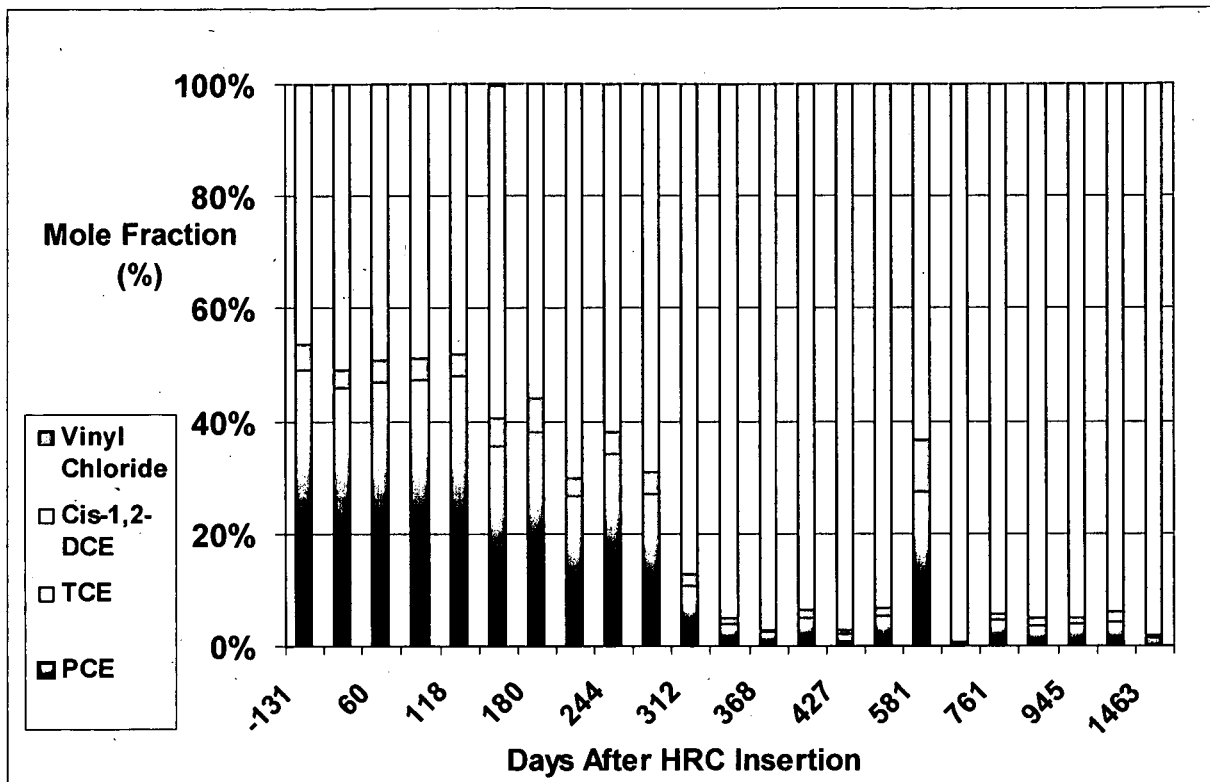
Figure 27. Mole Fraction Percent of PCE in Source Area Well 30900 Relative to its Degradation Products Over Time

Figures 27 and 28 show the mole fraction (in percent) in wells 30900 and 31001. The relative amounts of degradation byproducts increase as additional degradation occurs and the zone of anaerobic degradation increases. Eventually these byproducts are also degraded and their mole fraction decreases as it did in the source area in October of 2002. The release of additional PCE in the spring of 2003 and again in 2004 appears to have added additional degradation products and again increasing the ratio of cis-1,2 dichloroethene to the other species, suggesting that the area of biological activity increased again as in 2001.

Figures 24 and 27 also show cis-1,2-dichloroethene occurs at higher concentrations in the source area than downgradient. The accumulation of cis-1,2-dichloroethene at enhanced biodegradation sites is known both here and at other sites. Although there could be others, only one type of bacteria, *Dehalococcoides ethenogenes*, is currently known to anaerobically degrade cis-1,2-dichloroethene (Maymó-Gatell, et al. 1999). Recent research (Kean, 2003) has found that when the concentration of hydrogen donors is high, cis-1,2-dichloroethene degradation is arrested and will accumulate. As previously mentioned, the increase in hydrogen donors is associated with the rise in water table flushing HRC®, ketones, and other hydrogen donors out of the vadose zone. When the concentration of hydrogen donors drops, such as downgradient from the insertion area, *Dehalococcoides ethenogenes* is better able to compete with other bacteria (methanogens) for available resources and cis-1,2-dichloroethene concentrations drop.

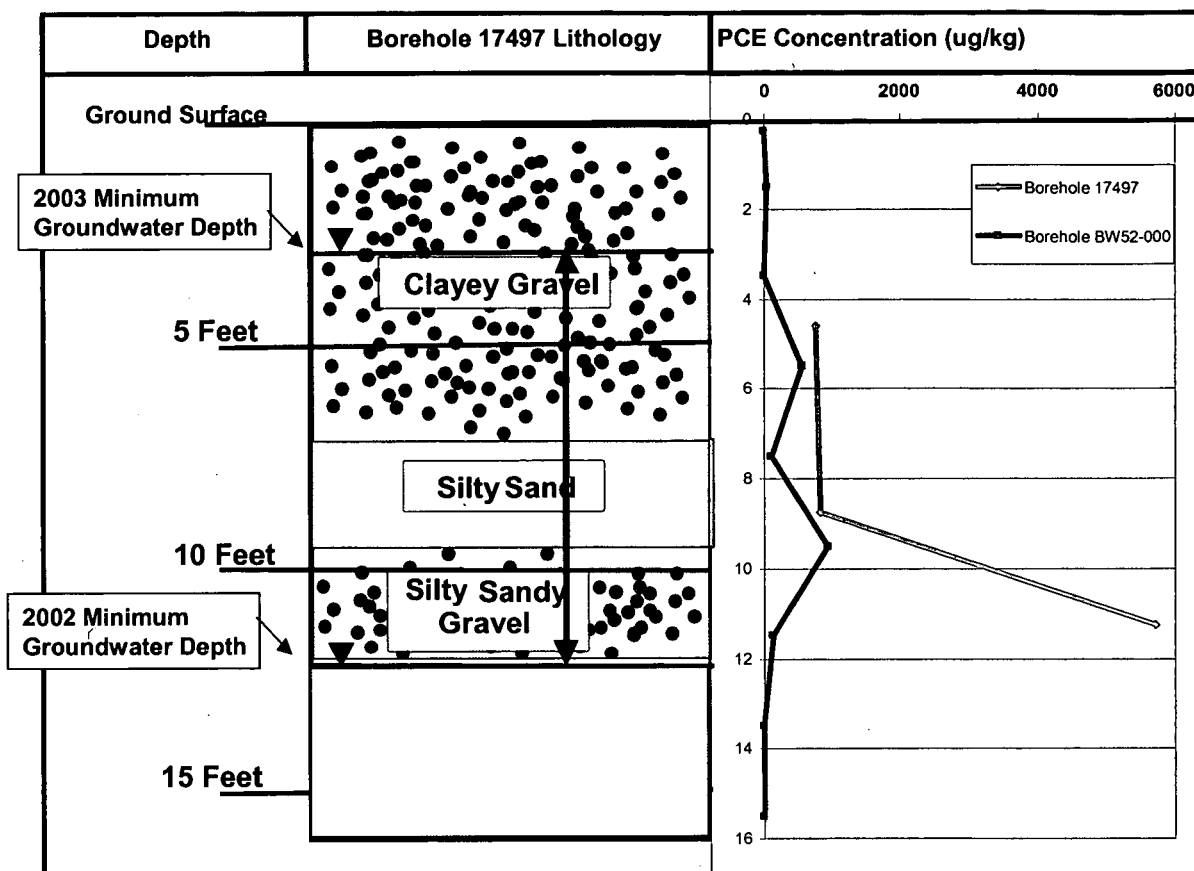
Figure 30. Lithology and Soil Concentrations of PCE (ug/kg) vs. Depth (feet from surface) in the Source Area

Figure 30 shows the differences in PCE concentration with depth between the original soil sample and the sample after treatment. Prior to HRC® insertion, the highest concentration of PCE was 5,700 micrograms per kilogram (ug/kg) occurring below the water table at a depth of 11.25 feet. The more recent sample from the corresponding borehole interval had a PCE concentration of 140 ug/kg or a 97.5 percent reduction in concentration. As shown on Figure 30, there appears to have been a reduction in PCE both above and below the water table.

Also shown on Figure 30 are the minimum groundwater depths for 2002 and 2003. This illustrates how groundwater levels rise and fall through contaminated vadose zone soils, the likely source of both additional HRC and contaminants. Because this rise in groundwater elevation was coupled with increased degradation, it is assumed that soil concentrations were further reduced.
